Cork County Energy Agency

Energy Audit

Midleton Library

December 2009

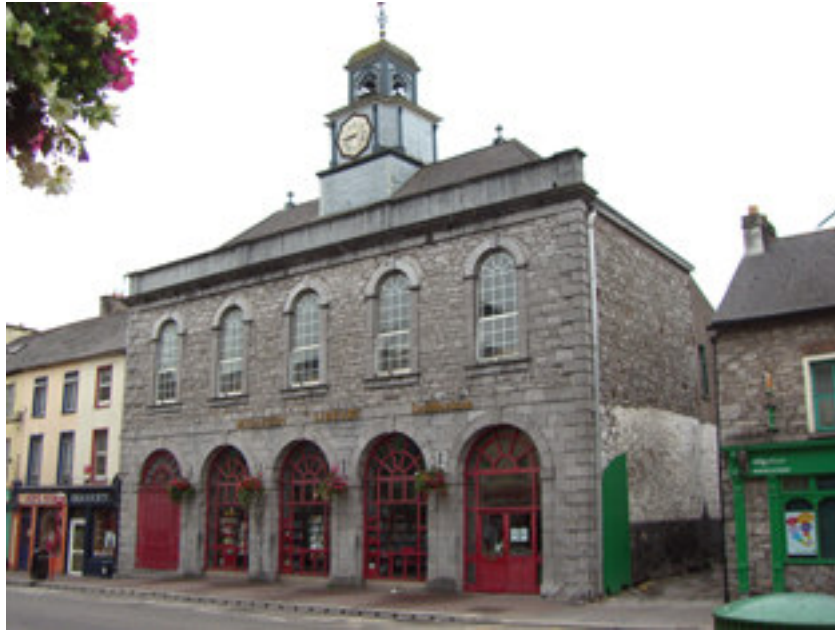
Figure 2.1 Midleton library building

Midleton library is located on the main street of Midleton town. The library is located in a heritage building that was formerly a market house which was built in 1798. Later it was used as a town hall before its current use as the town library.

The building footprint is approximately 324m². The façade is constructed of cut limestone and the perimeter walls are single leaf masonry of unknown width. All internal walls are timber frame partition walls with no insulation.

The main entrance and façade of the building is north east facing. There are five bays on the façade of the building which have single glazed windows.

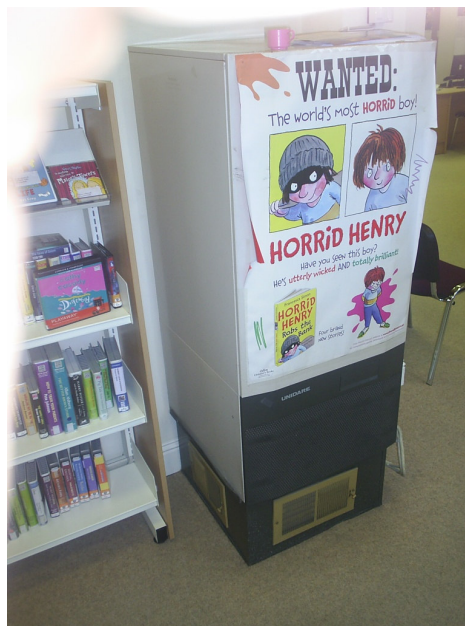
Figure 3.1 Storage heating unit

Electricity is the main heating source on site. The building is heated by three fan assisted storage heaters each with a rated heat output 10kW (figure 3.1). The heat output of each storage heater can be regulated on the control panel of the storage heater. The storage heaters are not under the control of a seven day time clock. One of the storage heaters has thermostatic control. A smaller storage heater provides heat for the store room. Heating for the canteen is done by electric element convection heater.

- While the electric storage heaters provide an effective heating system they are not required when the library is closed on Sunday. Switching them off would require a seven day timer to be fitted to the heating circuit.
- The manager should be aware of the use of under sink heaters for hot water heating. If left on overnight and at weekends these heaters are being used excessively. The ideal solution is to fit an electronic timer to the heating circuit.
- Given the age of the building there is little that can be done to reduce heat loss through the building fabric that would not involve major building refurbishment.
- The windows on the façade of the building are a big source of heat loss in the building. The only option would be to replace the existing windows and frames with new frames and double glazed glass panels. Given the cost and disruption to the building this is impractical.

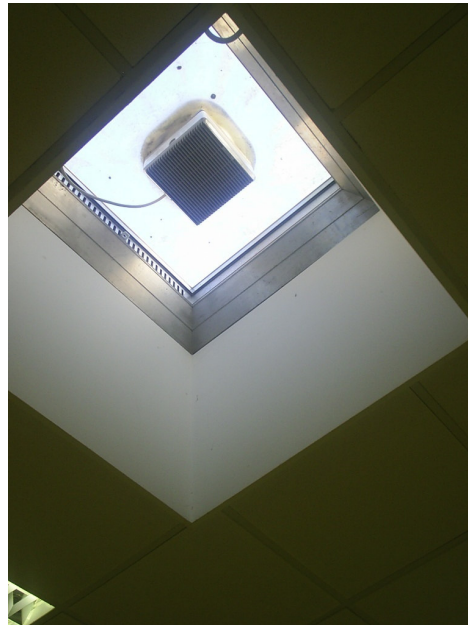
Figure 3.2 Ventilation fans in ceiling

Fans in the skylights provide mechanical ventilation for the library (figure 3.2). These are controlled by switches on a control panel but are not in regular use.

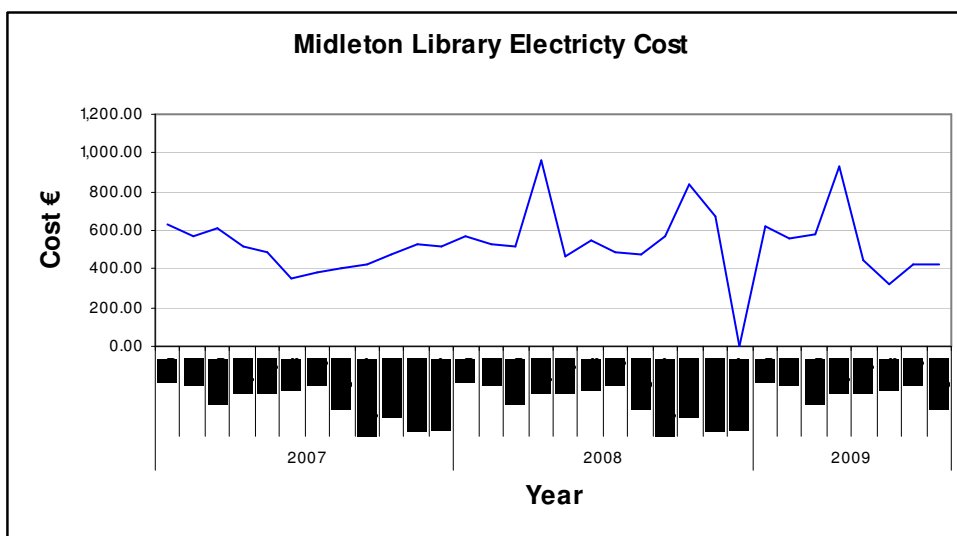
Figure 3.2 Midleton Electricity Cost

The account is on general purpose night saver tariff. The town council electricity is supplied by Energia. Electricity cost and consumption can be seen in figure 3.2 and 3.3.
