# **Cork County Energy Agency**

**Energy Audit**

**Youghal Area Office**

December 2009

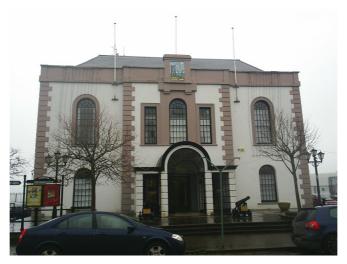
Figure 2.1 Mall House Youghal

Mall House is occupied by Youghal Town Council (figure 2.1). It houses the administrative offices of Youghal Town Council and a theatre that is used by the court service and local theatre groups. The town council administrative offices and chambers are located on the ground floor and the theatre is located on the first floor.

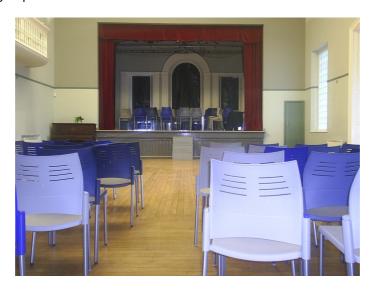
Figure 2.2 Theatre Mall House Youghal

The offices are open five days a week during regular business hours from 9am to 5pm. Hours of occupancy for the office do not vary throughout the year. The theatre (figure 2.2) is used by the court service approximately one day per month and is used infrequently by local theatre groups.

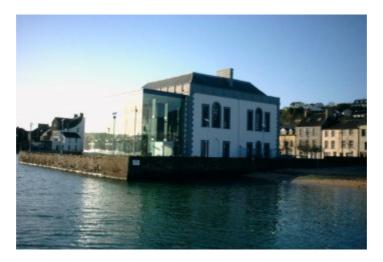
Figure 2.3 Glass Atrium at rear of building

From 2002-2004 the building underwent renovations which included the addition of a glass Atrium on the south side of the building which now serves as a reception area (figure 2.3).

- Given the age of the building there is little that can be done to reduce heat loss though the walls and windows.
- The Atrium in the building makes excellent use of passive solar gain. In the summer months the passive solar gain is sufficient to heat the building which means large energy savings.

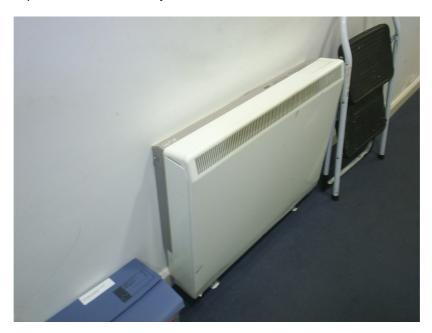
Figure 3.3 Storage heater in office area

Electricity is used as the main heating fuel on site. The main heat sources are storage heaters (figure 3.3) apart from the Town Clerks office which has an air conditioning unit (figure 3.4). There are a total of 39 storage heaters in the building. These are programmed to come on by night heating electricity meter. Almost half of these storage heaters are in unoccupied spaces and are normally switched off.

- The storage heaters in the town council offices and area engineers offices are heating the building at weekends when the offices are unoccupied. Time clocks can be fitted to the night storage heating circuits to turn off storage heaters off on Friday and Saturday night. This can save 28% on the cost of heating the offices. The measure has been carried out in four other council offices to good effect.

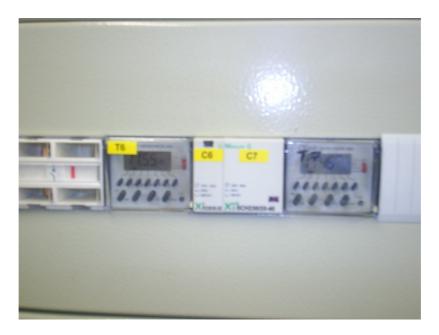
Figure 3.5 Timers on immersion heaters

Hot water for sinks and the canteen is provided by two separate electric immersion heaters in the attic. Both are controlled by a time clock (see figure 3.5), the programming of this time clock could not be determined at the time of the site visit.

- The control of the hot water heating is not well understood. An electrician should be consulted in to clarify how the timers are programmed and instruct the town foreman on how to change the time scheduling of the immersion heaters.

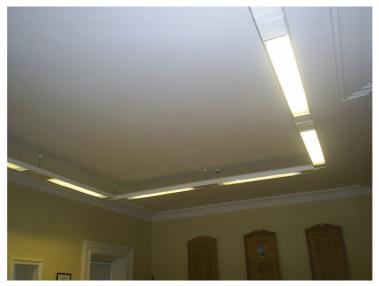
Figure 3.6 Old T12 fluorescent lighting in the council chambers

The major electricity use excluding heating is lighting and ICT services. The majority of the lighting in the building is compact fluorescent. Indoor lighting is controlled by switches in the offices. All compact fluorescent lighting in the offices have modern luminaires. There are some old luminaires in the council chambers which use T12 lamps with magnetic ballasts (see figure 3.6).

- Most of the lighting and luminaries in the offices are modern and not in need of replacement with the exception of those in the council chambers.
- The lighting in the council chambers is old and inefficient. The T12 fluorescent tubes should be replaced with modern T8 fluorescent tubes. This will not yield significant savings as the council camber is occupied infrequently. The more cost effective solution would be to replace the old lamps upon failure with more modern alternatives.
- The toilets are an ideal place to install occupancy sensors as they are occupied infrequently.

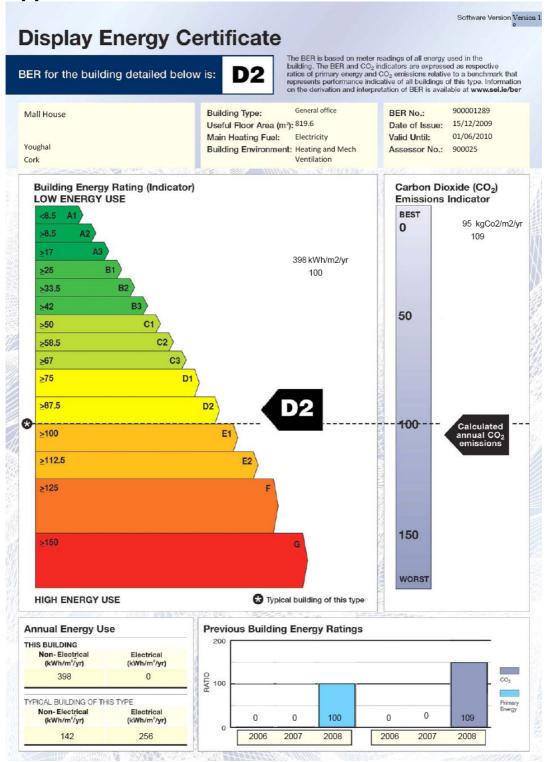
# Appendix A – DEC Mall House

Performance indicators are used to compare the energy performance of similar buildings. They are calculated by comparing the energy used in a building over a one year period against another common metric. This can be floor area, hours of opening or number of users. The performance indicator for Mall House was calculated using total floor area. This energy performance indicator was calculated using SEI's Display Energy Certificate tool. The office received a D2 rating. A copy of the DEC can be seen in Appendix A.
